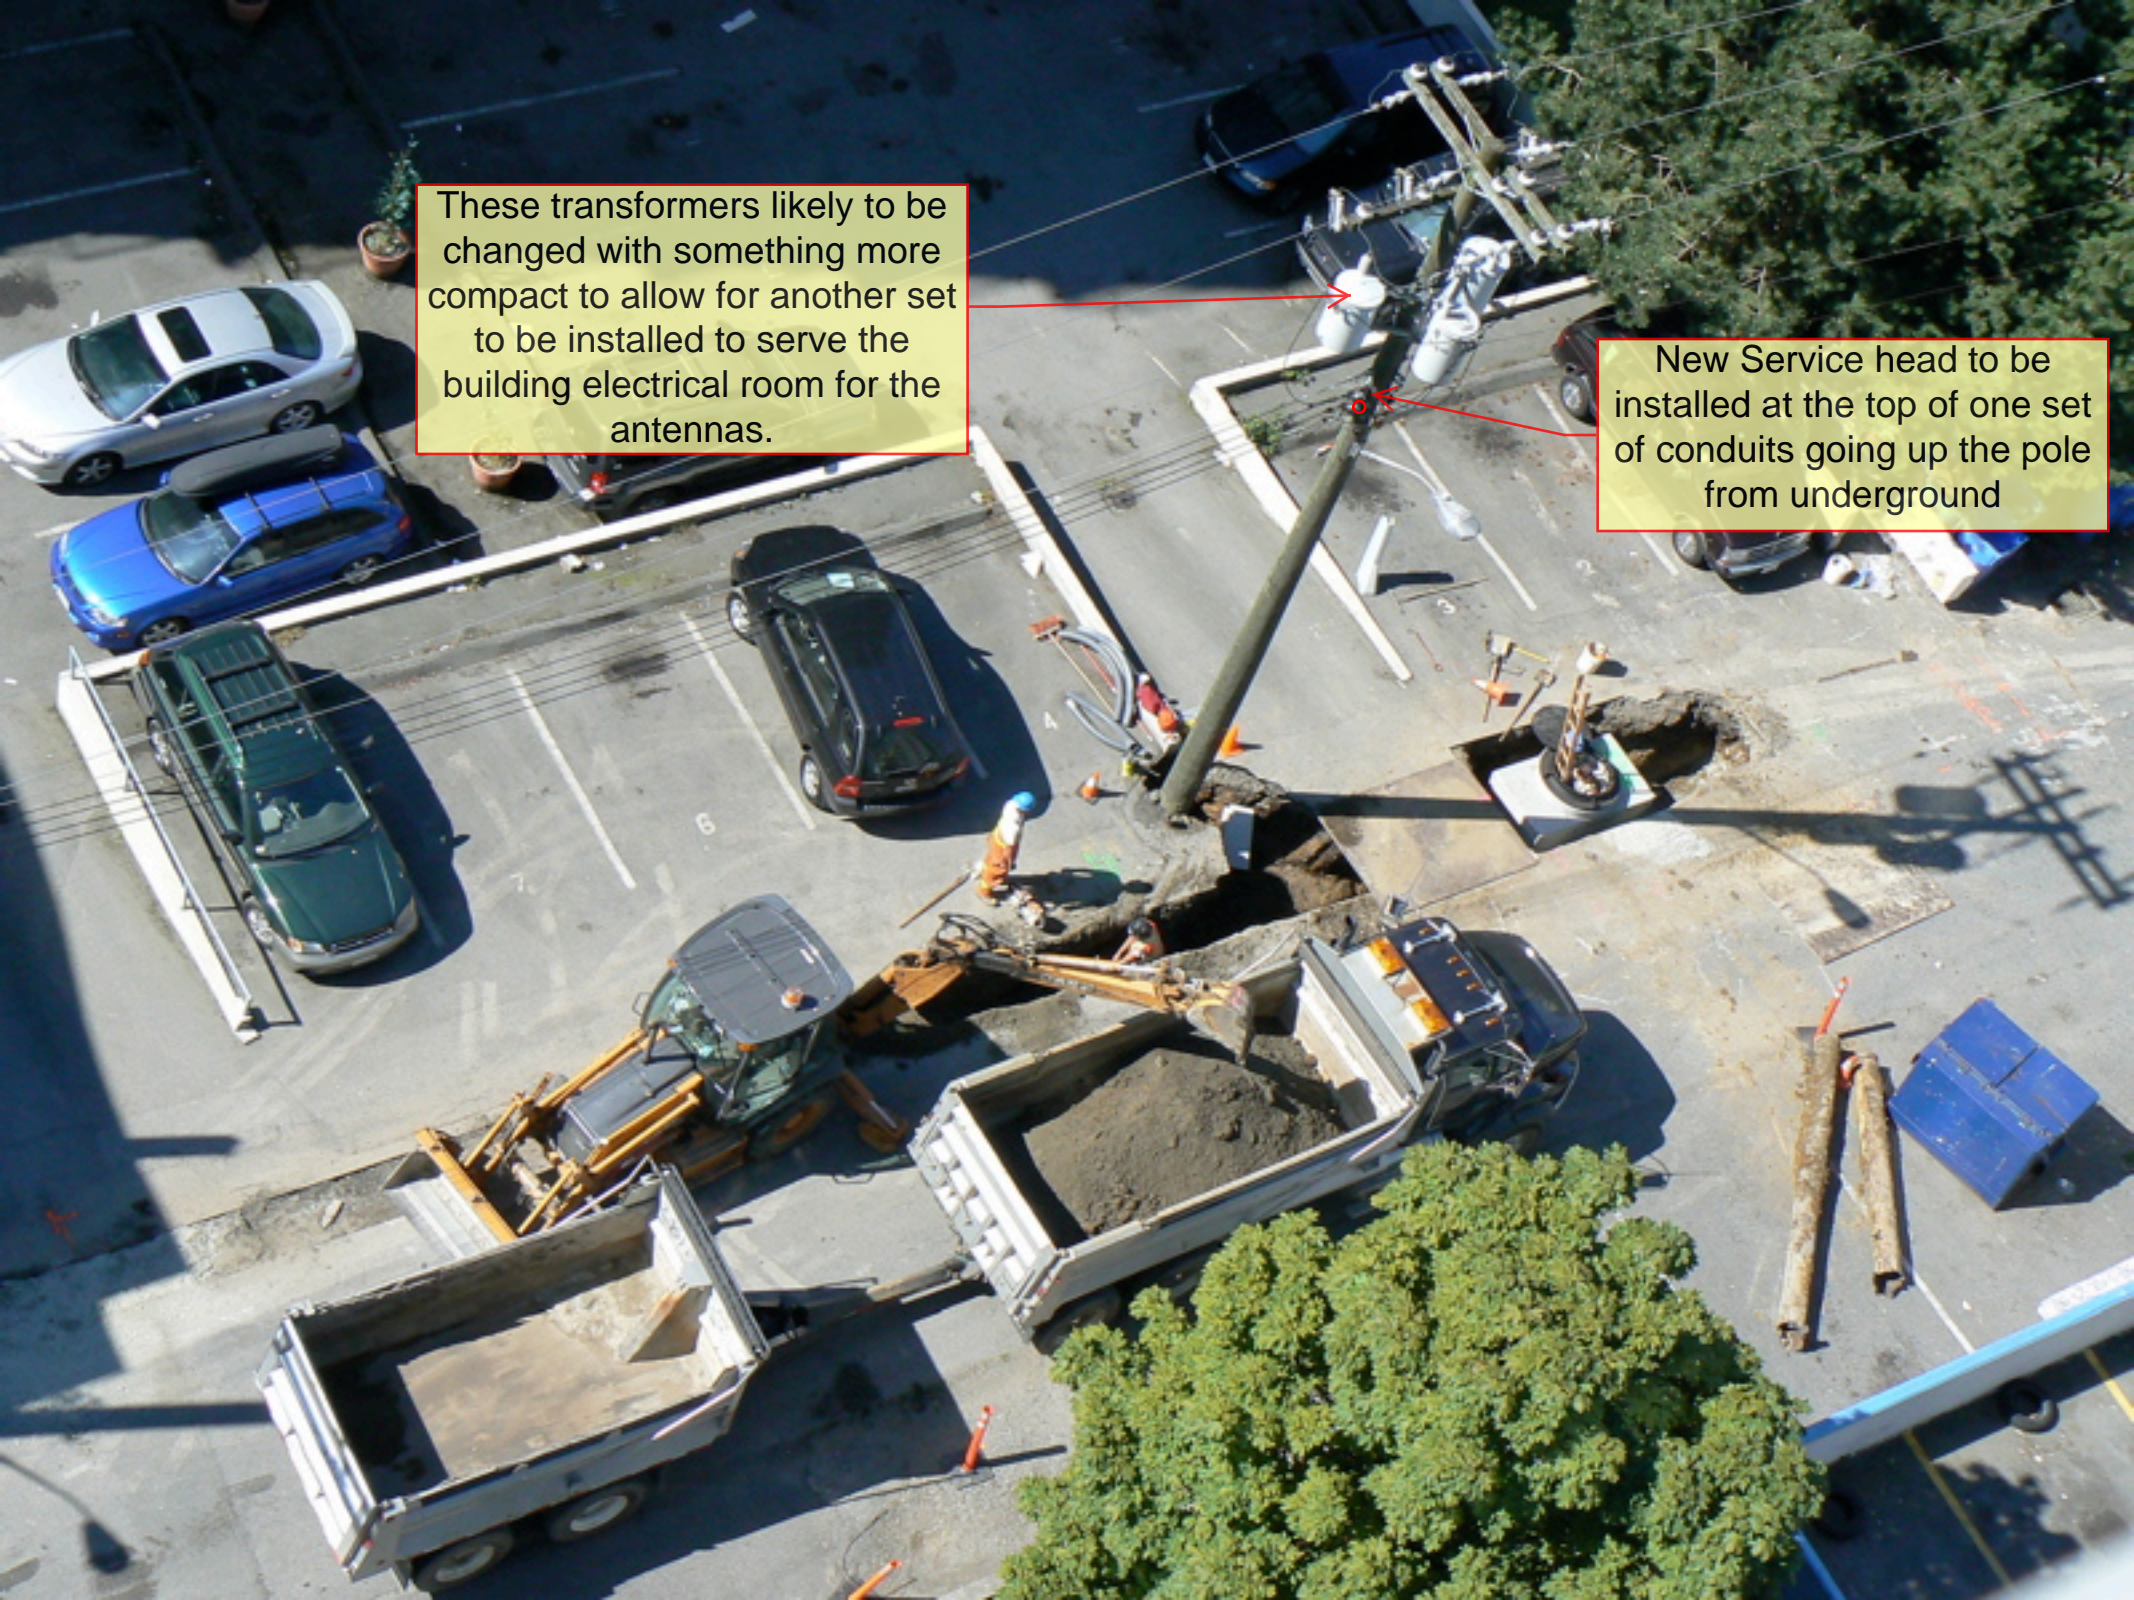
These transformers likely to be changed with something more compact to allow for another set to be installed to serve the building electrical room for the antennas.

New Service head to be installed at the top of one set of conduits going up the pole from underground

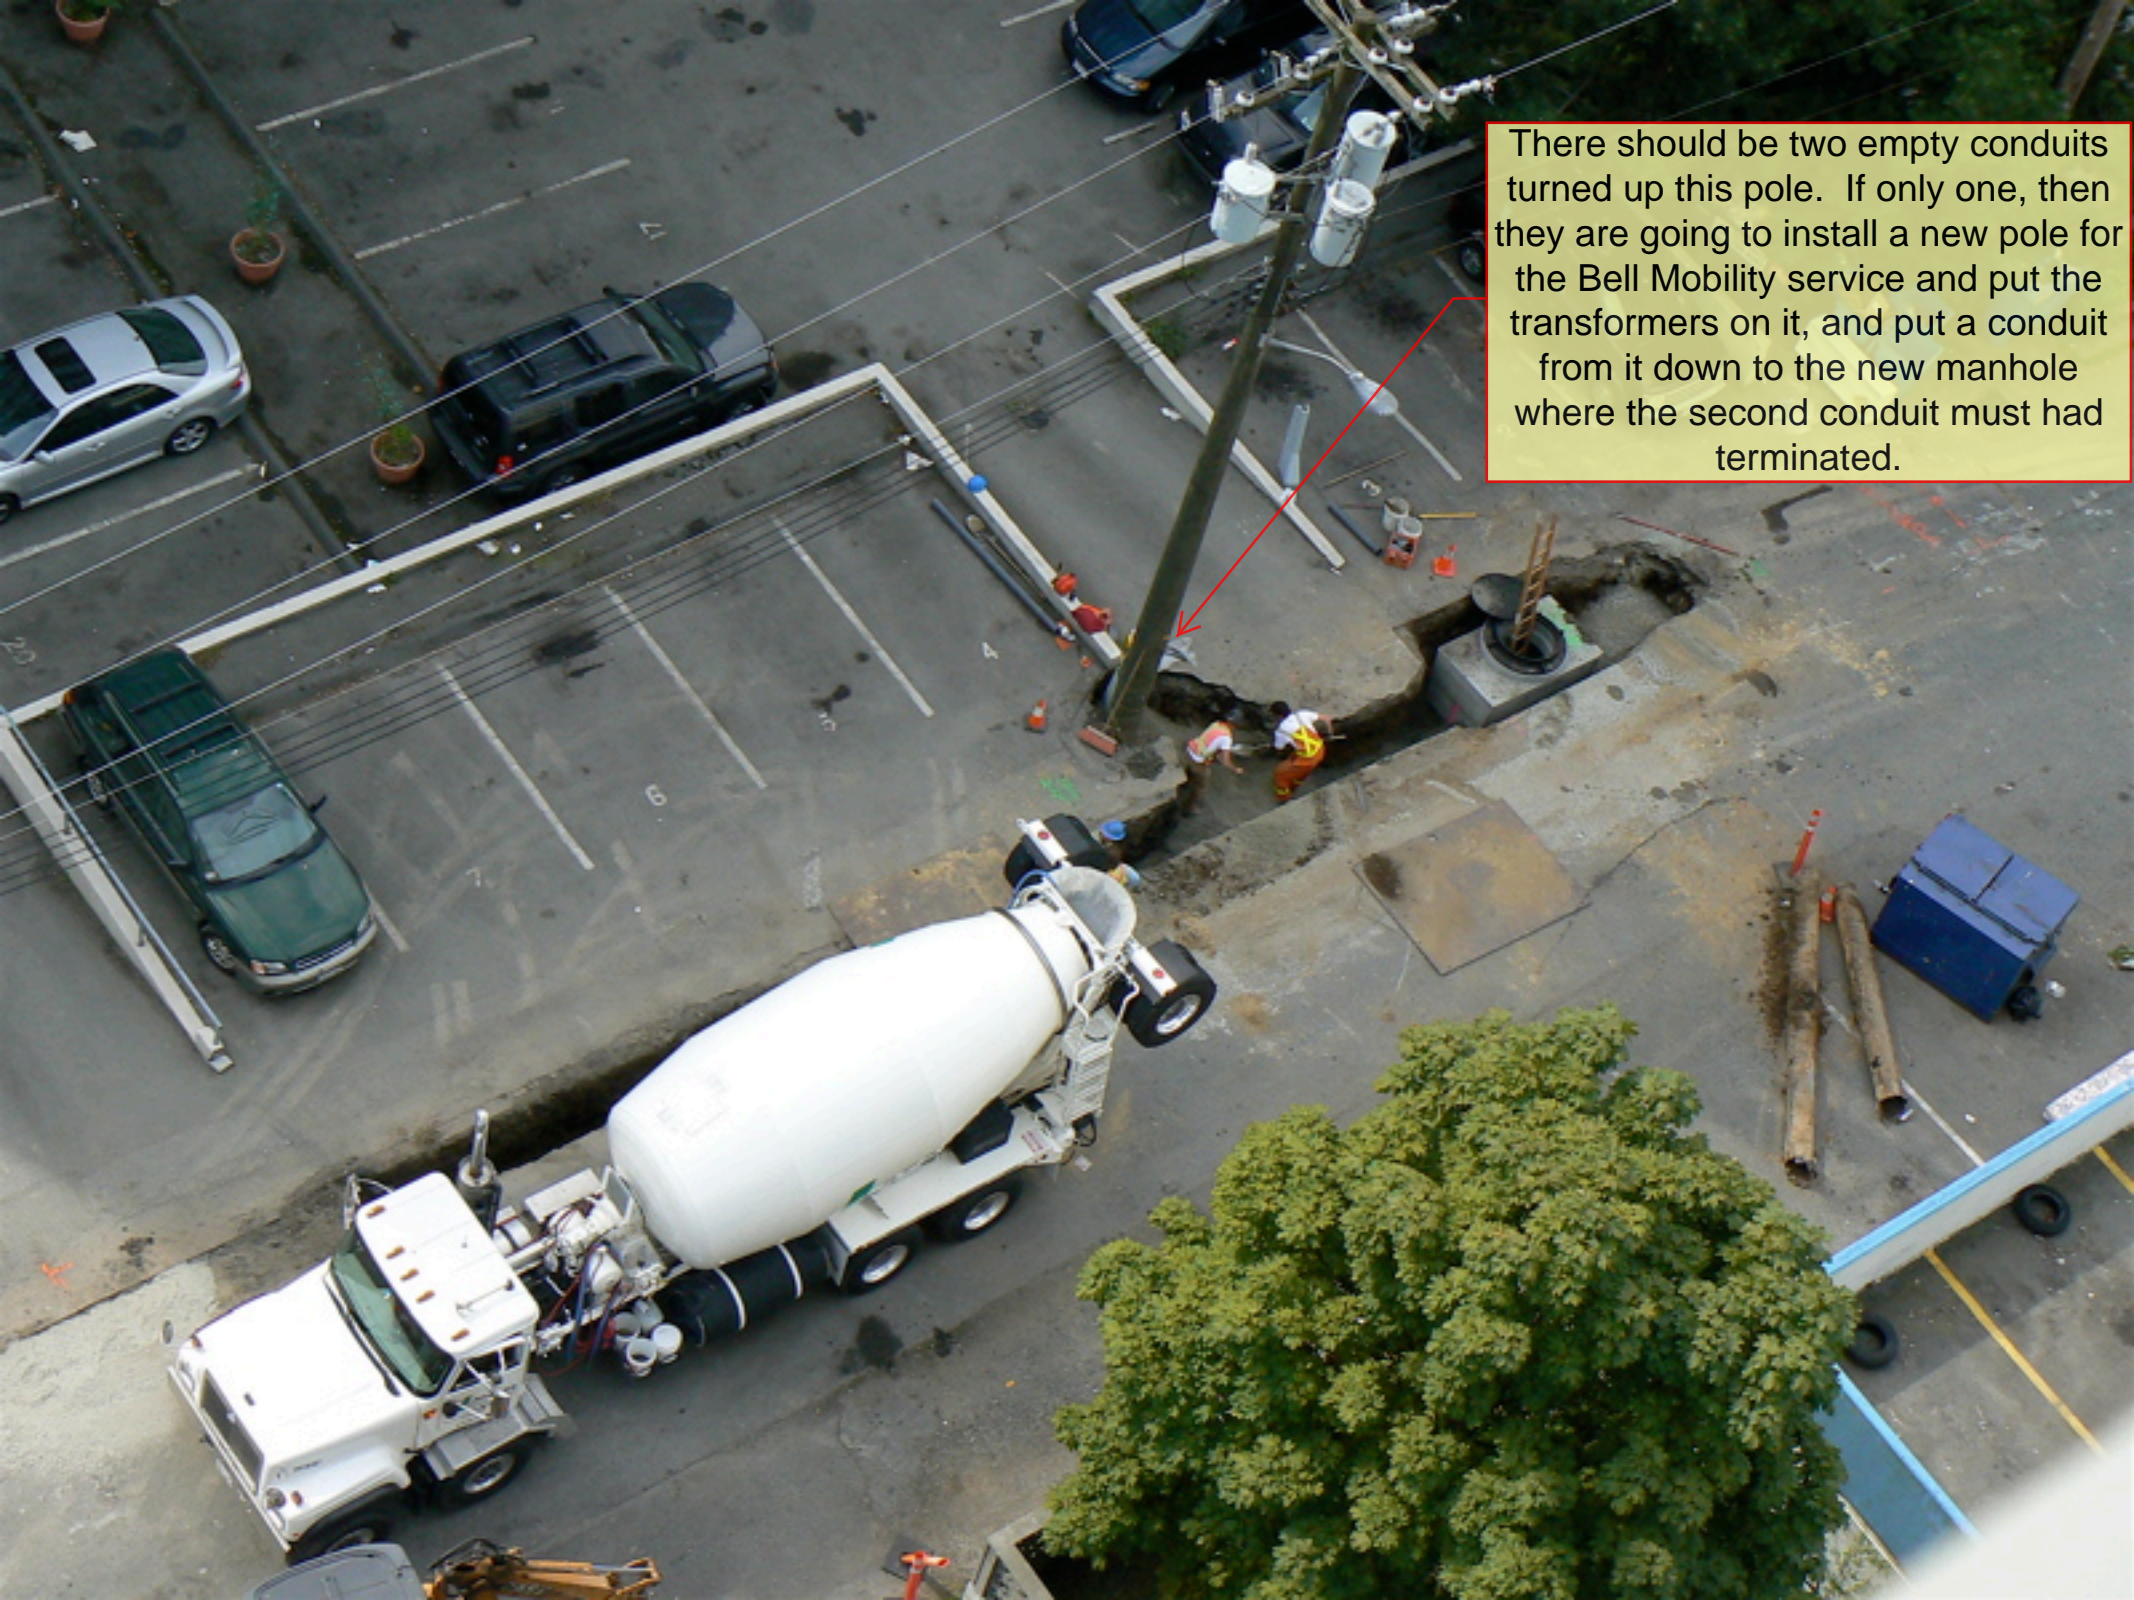
There should be two empty conduits turned up this pole. If only one, then they are going to install a new pole for the Bell Mobility service and put the transformers on it, and put a conduit from it down to the new manhole where the second conduit must had terminated.

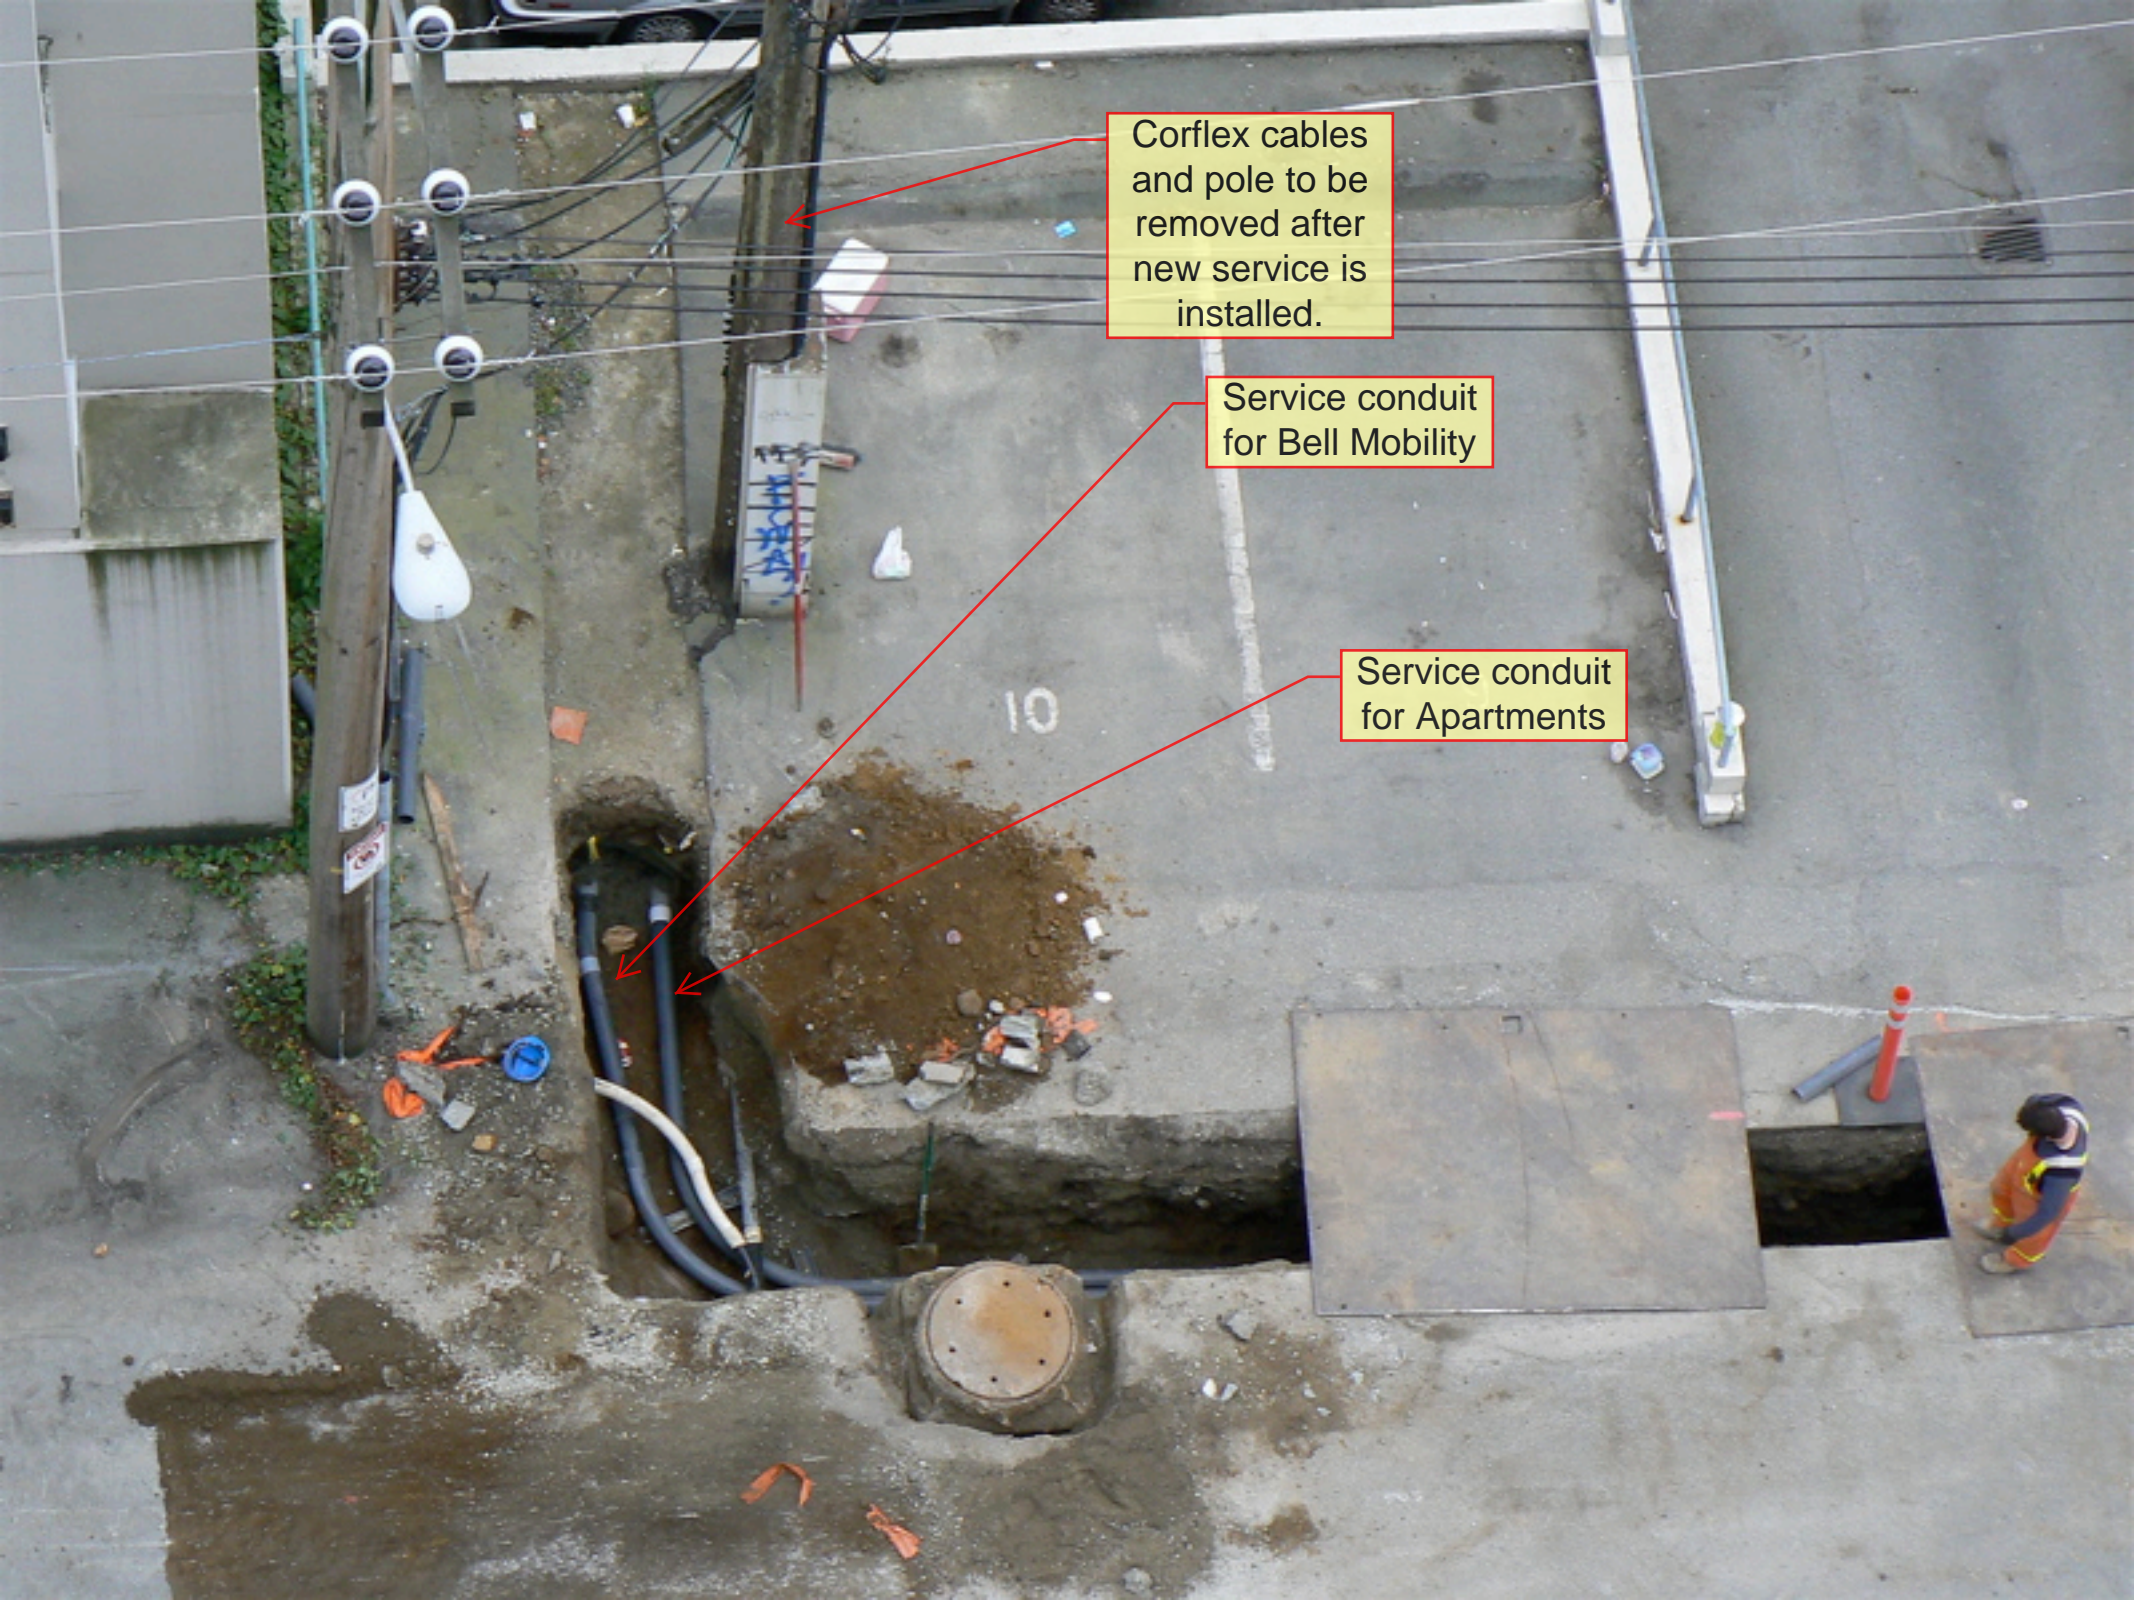
An aerial photograph of a utility trench cut into a concrete sidewalk. On the left, a wooden utility pole is visible with several white insulators and a white street light. A trench has been dug, revealing several black and white cables. A worker in an orange safety vest is visible in the bottom right corner, near a large metal manhole cover. Three red arrows point from text boxes to specific features in the trench: one to a bundle of black cables, one to a black conduit, and one to a white conduit. The number '10' is painted on the concrete sidewalk.

Corflex cables
and pole to be
removed after
new service is
installed.

Service conduit
for Bell Mobility

Service conduit
for Apartments

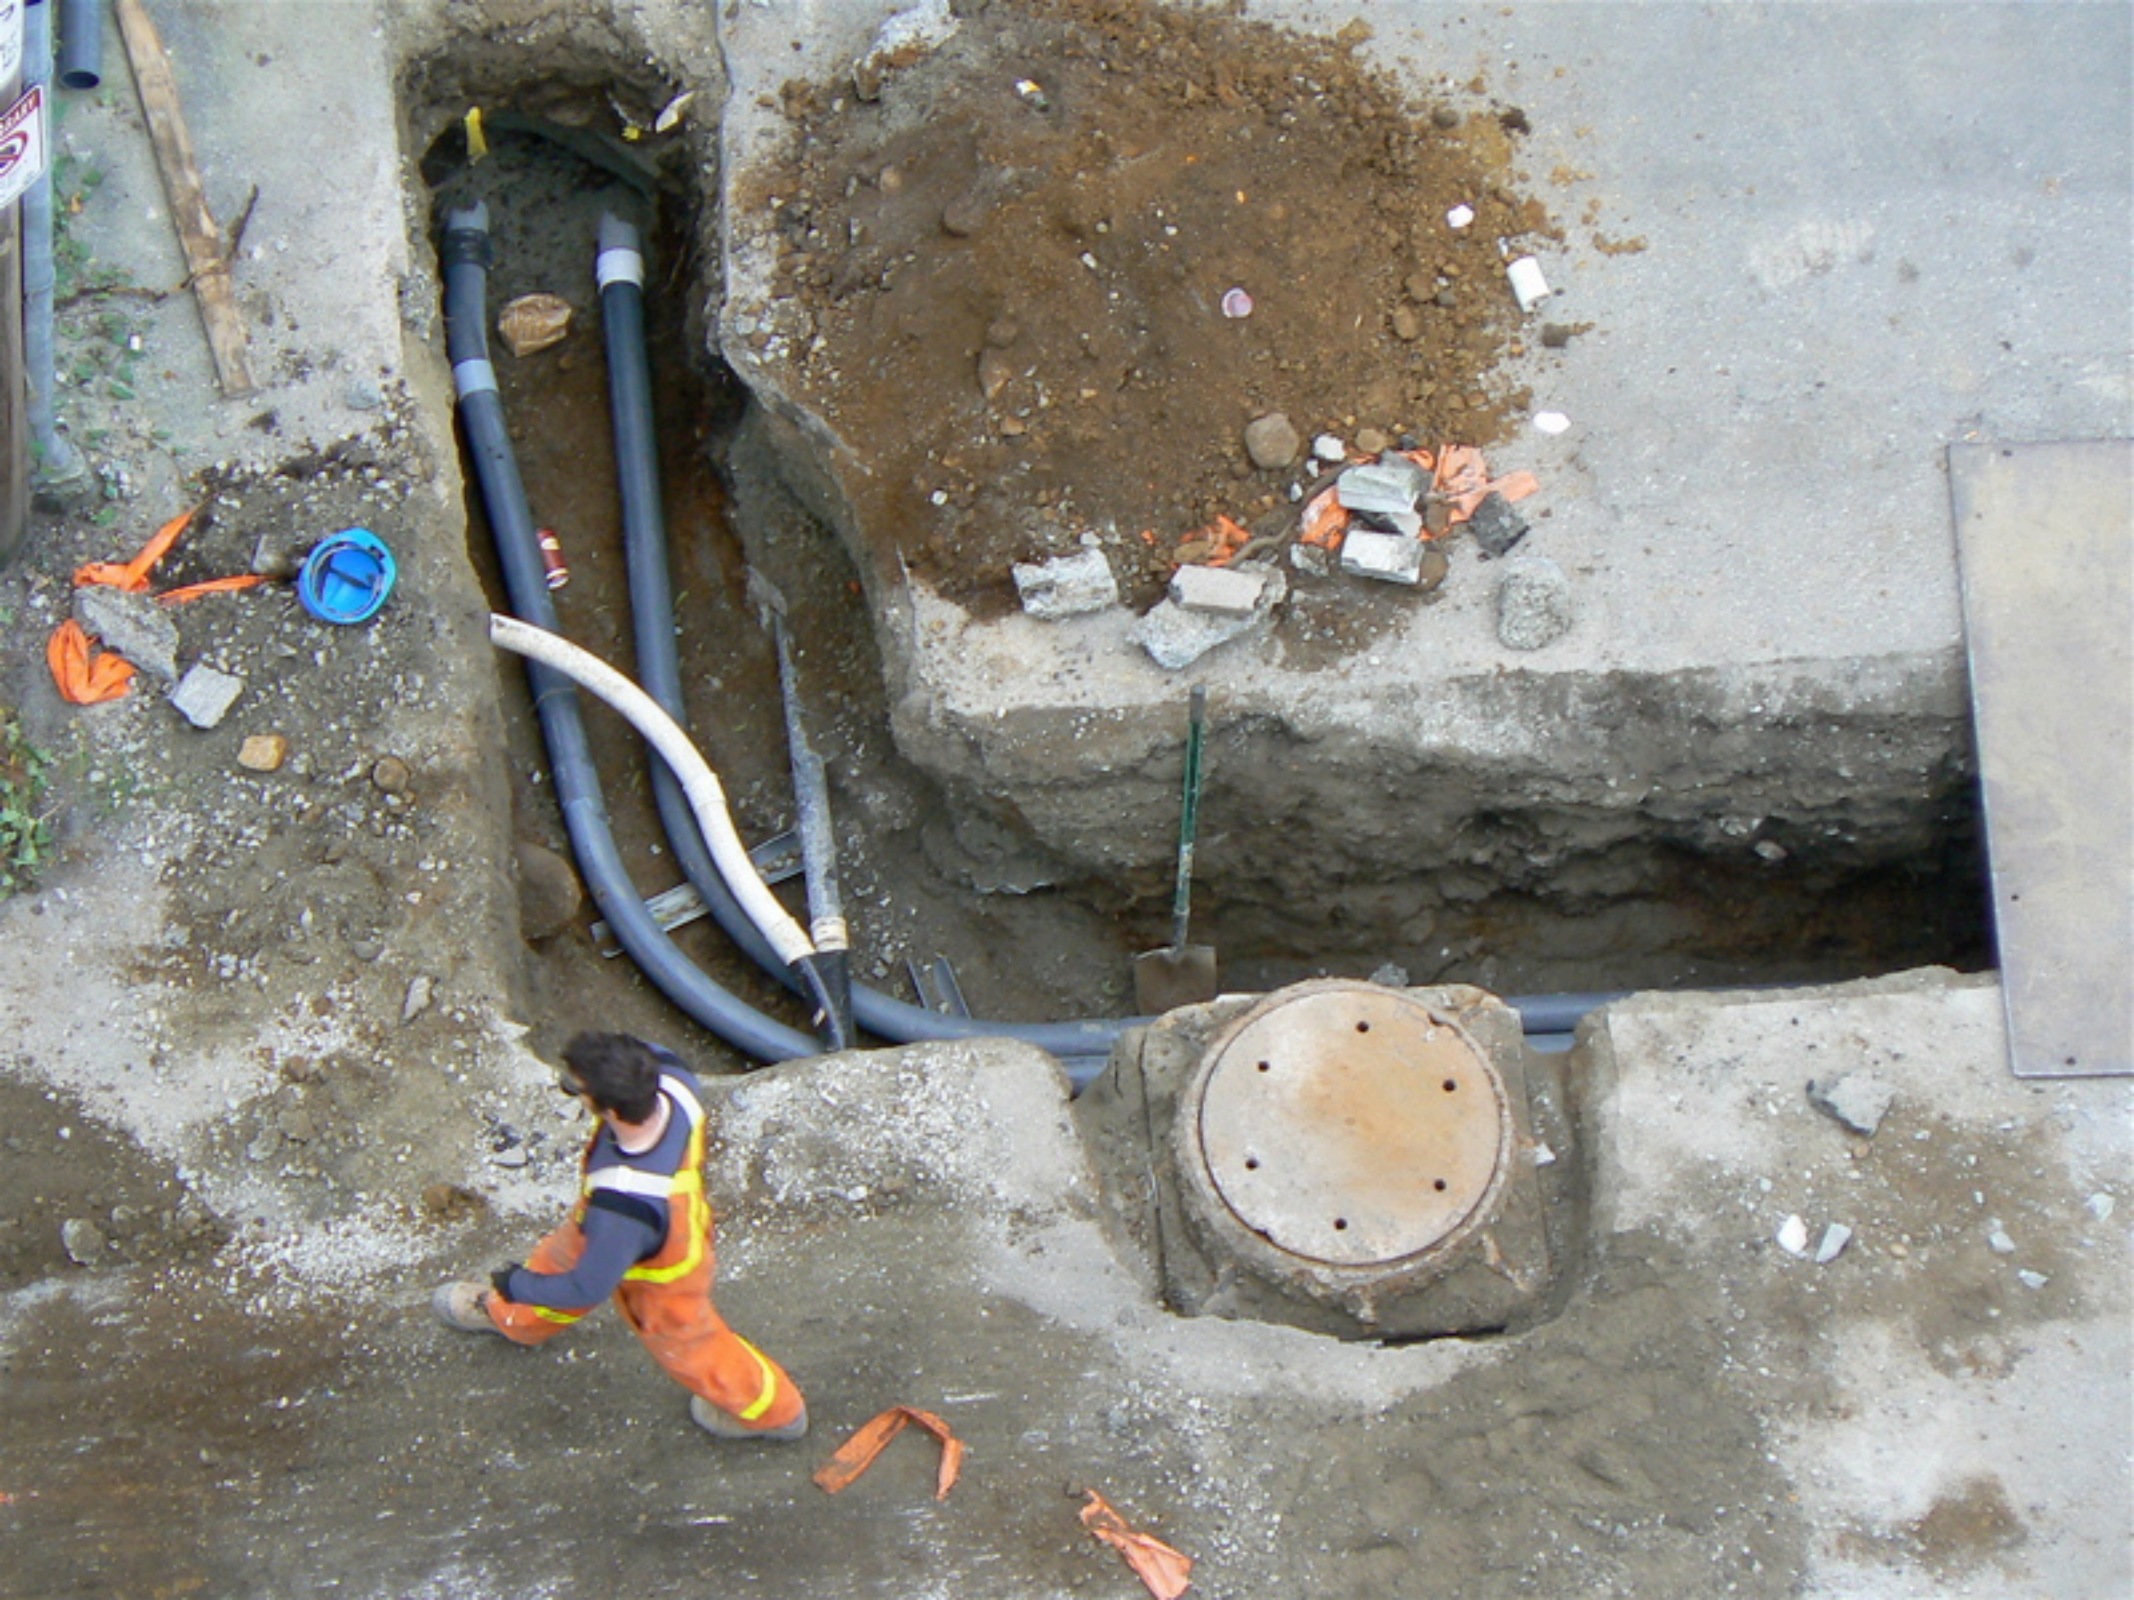
This is approximately where the standby generator will feed in through this box.
